Bulletin No:	B408CRM148-0
Release Date:	October 12, 2006
Effective Date:	October 12, 2006
Supersedes:	N/A
Completion Date:	Immediately
Page:	1 of 8

SERVICE BULLETIN

Ride Name: CHAOS

Passenger Restraint Bar Locking System Inspection and Operational Check
(Rides Retrofitted With Ratchet Lock Kit Only)

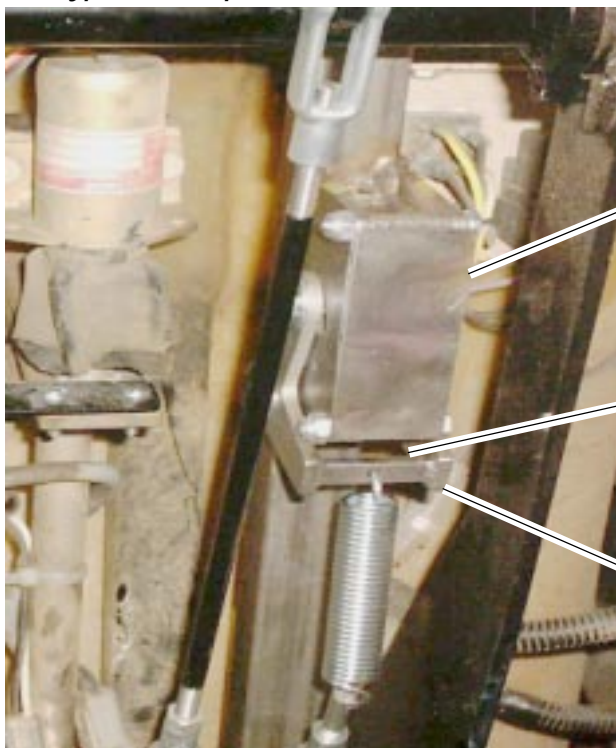
*Manually Releasing the Ratchet Locks
(Typical for Lap Bar or T-Bar Ratchet Lock)*

Ratchet lock housing

*Insert screwdriver here,
between ratchet lock housing
and release arm. Pry down-
ward to release the ratchet lock*

Release arm

1. With the LAP BAR SWITCH on the operator's control console in the "Close" position, close both of the shoulder bars on one vehicle.
2. From the back of the vehicle, have the helper manually release the ratchet lock for one shoulder bar, using a screwdriver as shown.
