## SAFETY NOTE

### GO KART HAIR ENTANGLEMENT 2011

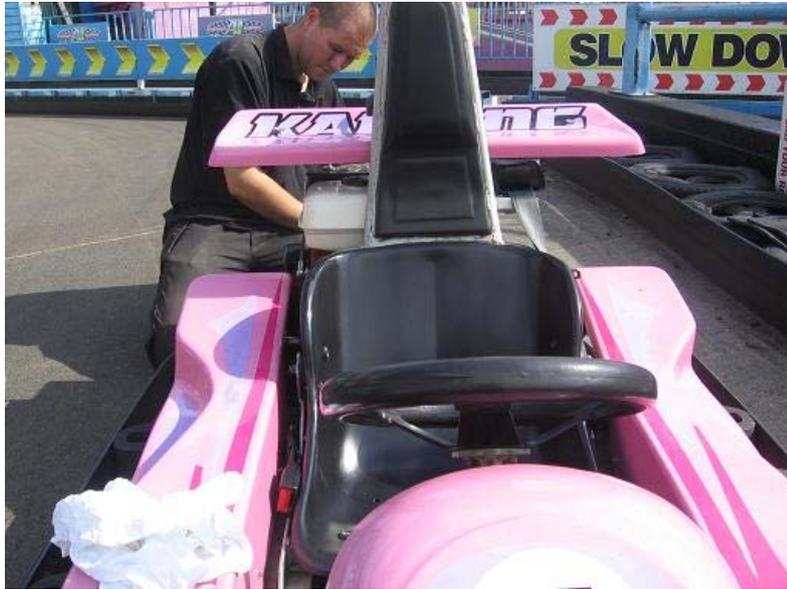
Fig 1.

A 14 year old girl was driving a Go Kart at a fixed amusement park. The Kart was a standard Formula K machine as shown below. The kart was powered by a Honda GX 160 4 stroke recoil start motor.

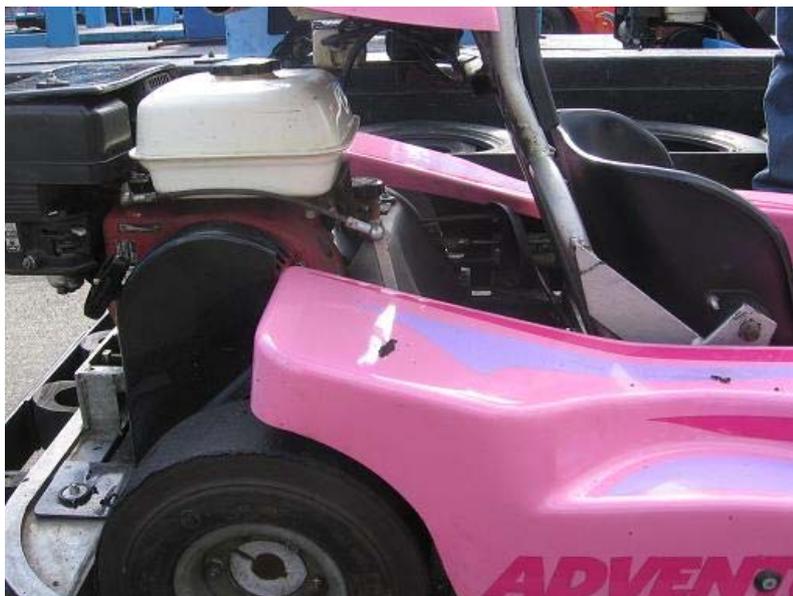
Fig 2.

Whilst driving the kart around the track her hair entered the cooling slots on the recoil starter and became entangled in the cooling fan. Prior to the accident the operator had fitted a guard which partially covered the fan (see Fig 2).

This secondary guard had, as can be seen; only a small gap around the perimeter edge but this was sufficient for her hair to be drawn in and become entangled.

A length of hair was torn from her head which resulted in a significant wound to the scalp. The wound was 12cms long and required 12 stitches.

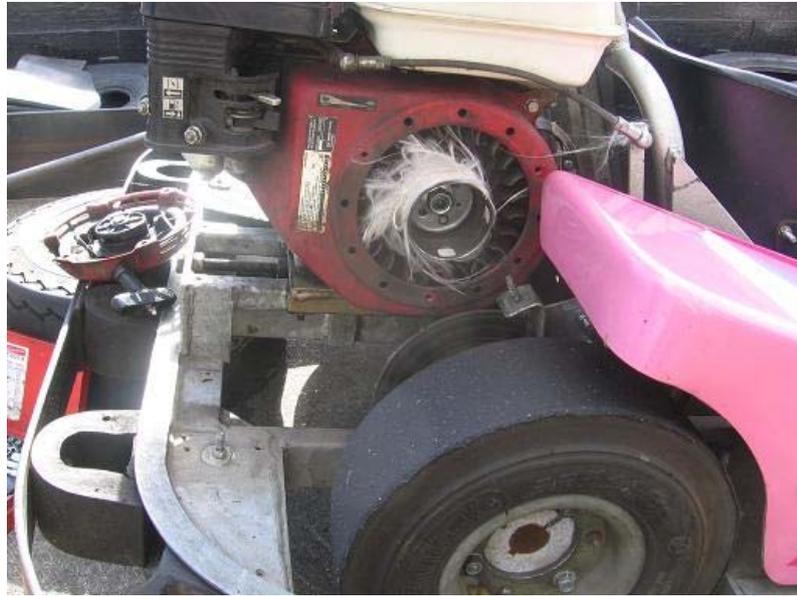
Fig 3 (Reconstruction)

A reconstruction of the incident was conducted with the recoil starter cover in place and using some nylon fibre to simulate the hair. As can be seen from Fig 3 below the fibre was drawn through the engine cooling holes on to the recoil starter fan.
