SAFETY NOTE

GO KART HAIR ENTANGLEMENT 2011

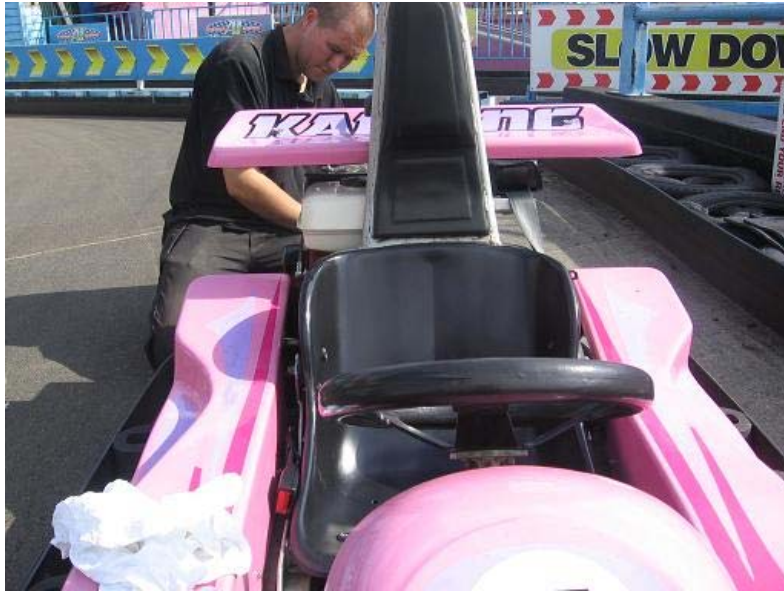
Fig 1.

A 14 year old girl was driving a Go Kart at a fixed amusement park. The Kart was a standard Formula K machine as shown below. The kart was powered by a Honda GX 160 4 stroke recoil start motor.

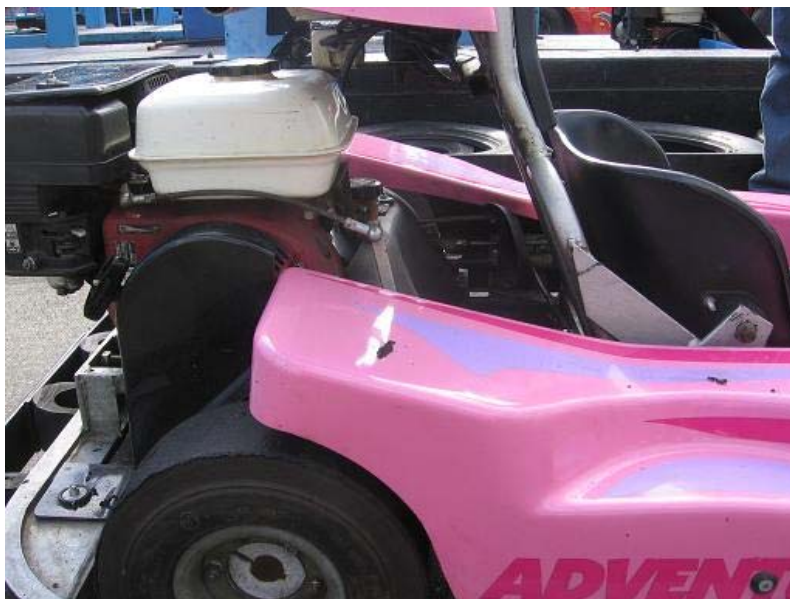
Fig 2.

Whilst driving the kart around the track her hair entered the cooling slots on the recoil starter and became entangled in the cooling fan. Prior to the accident the operator had fitted a guard which partially covered the fan (see Fig 2).

This secondary guard had, as can be seen; only a small gap around the perimeter edge but this was sufficient for her hair to be drawn in and become entangled.

A length of hair was torn from her head which resulted in a significant wound to the scalp. The wound was 12cms long and required 12 stitches.

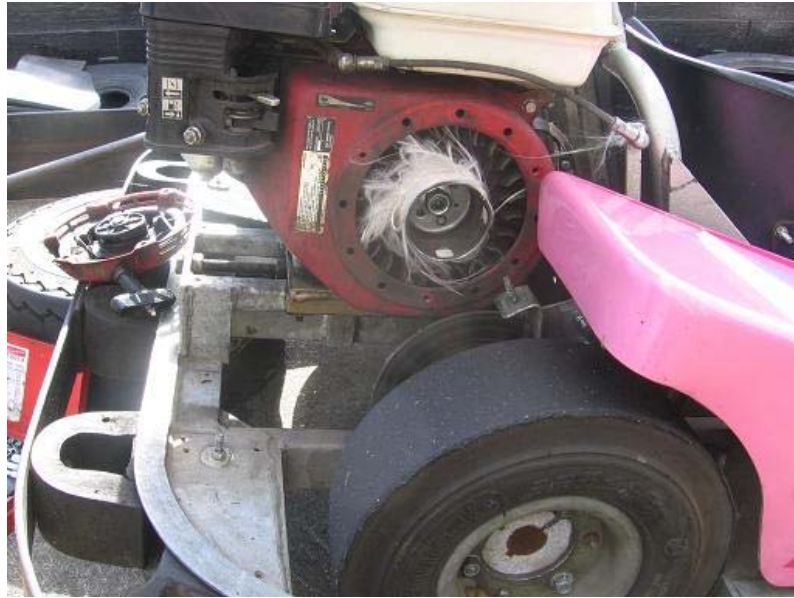
Fig 3 (Reconstruction)

A reconstruction of the incident was conducted with the recoil starter cover in place and using some nylon fibre to simulate the hair. As can be seen from Fig 3 below the fibre was drawn through the engine cooling holes on to the recoil starter fan.
